ANALYSIS OF A WWII T2-TANKER USING A VIRTUAL 3D MODEL AND CONTEMPORARY CRITERIA

C Bonnici, C De Marco Muscat-Fenech, and R Ghirlando, Department of Mechanical Engineering, Faculty of Engineering, University of Malta, Malta

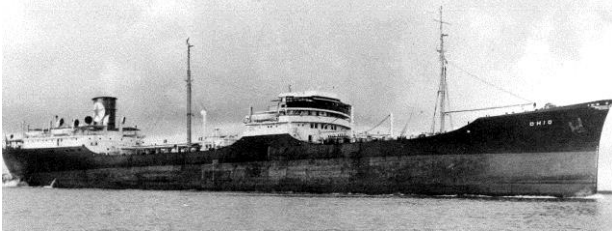
The S.S. Ohio (Figure 1) was an American T2-tanker, built by the Sun Shipbuilding and Drydock and owned by the Texas Company (later transformed into Chevron Corporation). Her keel was laid on the 7th of September 1939 and seven months later, on the 20th of April 1940, the

Figure 1: S.S. Ohio (Bogart, 1994)

The overall length (L_{OA}) of the S.S. Ohio was 156.7m, whilst the length between perpendiculars (L_{BP}) was equal to 147.8m. Her moulded depth (D) and moulded beam (B) were equal to 11.0m and 20.7m respectively (The Texas Company, 1940(a)), (Lloyd's Register, 1940), (Lloyd's Register, 1939). The tanker had a total deadweight of 14377t, whilst her lightship displacement (Δ_{LIGHT}) was equal to 5253t (The Texas Company, 1940(a)), Lloyd's Register, 1940), (Lloyd's Register, 1939). Her ship side was riveted, whilst her internal structure, bottom shell and deck plating were welded. The tanker was divided by two longitudinal bulkheads and a series of transverse bulkheads, forming 18 watertight compartments with a total cargo capacity of 1705m³ (The Texas Company, 1940(a)), (Lloyd's Register, 1940), (Lloyd's Register, 1939).

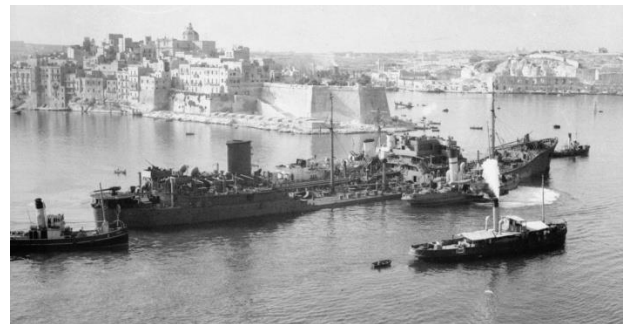
Figure 2: S.S. Freeboard of the S.S. Ohio at 0.76m (Cook, 1942)

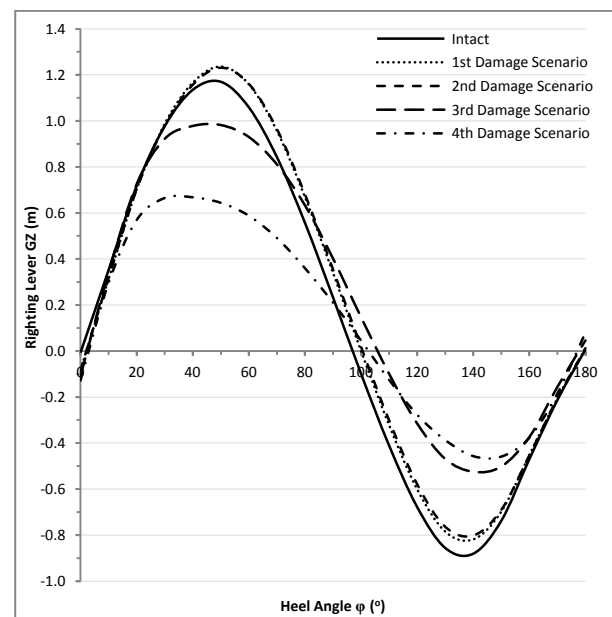
Graph 1: GZ curves for both intact and damage scenarios

The Lost Buoyancy Method was utilised to establish the equilibrium condition of each damage scenario. Using *Maxsurf Stability Enterprise*, the GZ curve of each damaged condition was plotted (Graph 1).

The GZ curves plotted for the first and second damage scenarios indicated that the stability of the S.S. Ohio was improved when compared with the intact condition. The maximum GZ of the first and second damage scenarios was equal to 1.3m, whilst that for the intact condition was equal to 1.2m. In addition, the Angle of Vanishing Stability (AVS) for both the first and second damage scenarios was equal to 100° whilst the AVS of the intact condition was equal to 98°. Thus a larger maximum GZ and AVS in the first two damage scenarios resulted in a larger area under the graph when compared with the intact condition, meaning that the S.S. Ohio could absorb higher heeling forces before she capsized. According to Patterson and Ridley (Ridley & Patterson, 2014), such a scenario occurs when there's either a reduction in displacement or an increase in freeboard. However, as shown in Graph 2, the S.S. Ohio experienced both a reduction in displacement, due to cargo loss from damaged tanks and a freeboard reduction, due to buoyancy loss from damaged compartments. Despite of this anomaly, stability was improved when the S.S. Ohio was damaged because for the first two damage scenarios, the reduction in displacement had a far more superior effect than the freeboard loss. Such a scenario was consolidated further, as despite the enhancement in the ship's stability when damaged, the Water Plane Area (WPA) decreased for each damage scenario (Graph 2). Such a scenario should have impaired the ship's stability, yet as shown in Graph 1, the ship's initial stability was also increased.

On the contrary, for the third and fourth damage scenarios, a reduction in stability was observed when compared to both the intact condition and the preceding damage cases. The maximum GZ for third and fourth damage scenarios was equal to 1.0m and 0.7m respectively, smaller than that obtained in the intact and first two damage scenarios. As a result, the area under the GZ curves of the last two damage scenarios was smaller than the intact and first two damage scenarios.

The GZ curves of the S.S. Ohio also indicated that at neither instant of damage was the tanker at risk of capsizing, as the angle of final equilibrium of each damaged condition was less than 3°. Despite the reduction in stability, the S.S. Ohio was never exposed to a capsizing risk. In fact, the late Allan Shaw, the last living crew member who was on-board the S.S. Ohio, confirmed that any list due to damage went unnoticed (Shaw, 2014).

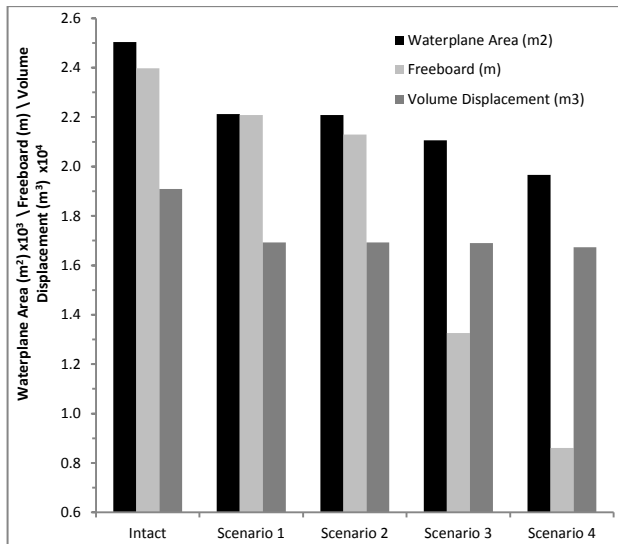
Graph 2: Column chart of waterplane area, volume displacement and freeboard variation between each intact and damage scenario

As shown in Graph 2, a reduction in both displacement and freeboard was also observed for the third and fourth damage scenarios. However the freeboard reduction was considerable when compared to the previous scenarios, whilst the displacement in each scenario remained almost constant. Hence the decline in stability for the last two damage scenarios was attributed to the freeboard reduction being more significant than the displacement loss. Even though a reduction in WPA was observed, the initial stability for the third and fourth damage scenarios was better than the intact condition.

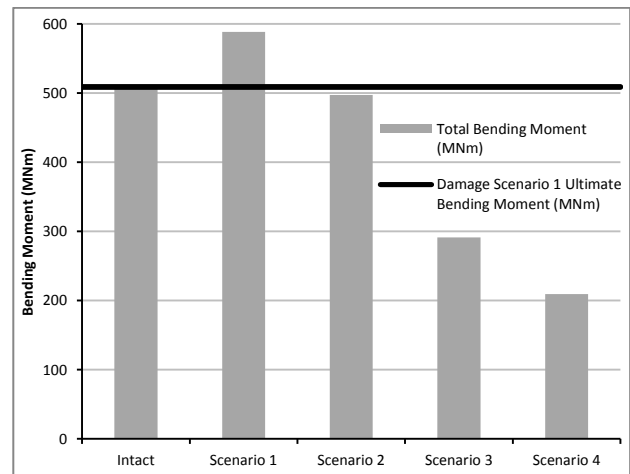
Graph 5: Bending moment for the intact and damage conditions

The results showed that the S.S. Ohio experienced the largest bending moment when the tanker was torpedoed (Graph 5). From the analysis, the maximum bending moment imparted to the S.S. Ohio in her first damage scenario was equal to 588.4MNm, higher than that obtained in the intact condition and 16% higher than the ultimate bending moment of 509.2MNm, as predicted by Paik et al's method for the first damage scenario (Graph 5). As such it was concluded that when the S.S. Ohio was torpedoed (first damage scenario) she was at the greatest risk of hull collapse, even though her internal structure was welded.

As further damage was inflicted elsewhere along the ship's length, the maximum bending moment decreased as shown in Graph 5. Such a scenario was also observed in separate studies carried out by Teixeira and Guedes Soares (Teixeira, Guedes Soares, 2009) and Horte, Skjong, Friis-Hansen, Teixeira and Viejo de Francisco (Horte, Skjong, Friis-Hansen, Teixeira and Viejo de

Franciso, 2007). A plausible explanation to such a scenario is that the remaining buoyant sections in her aft and forward regions were also flooded, sinking the ship deeper into the water, whilst decreasing the tanker's bending moment. The damage itself, served as a life saver, since despite the S.S. Ohio sinking further, the ship's sagged condition decreased.
