## COATINGS AND PERMANENT MEANS OF ACCESS – THE ANTI-CORROSION CHALLENGES.

(DOI No: 10.3940/rina.ijme.2011.a4.216)

### SUMMARY

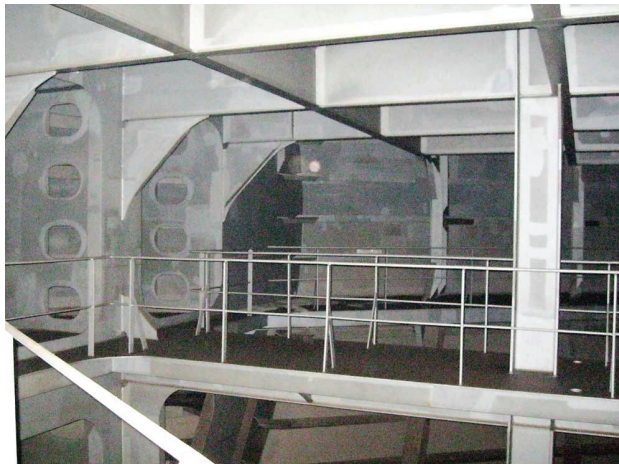
In order to obtain a long service life, the coating on the PMA should be applied to the same standards as for the ballast tanks themselves. Photograph 1 shows a well prepared ballast tank.

Photograph 1. Ballast tank with well prepared PMA.

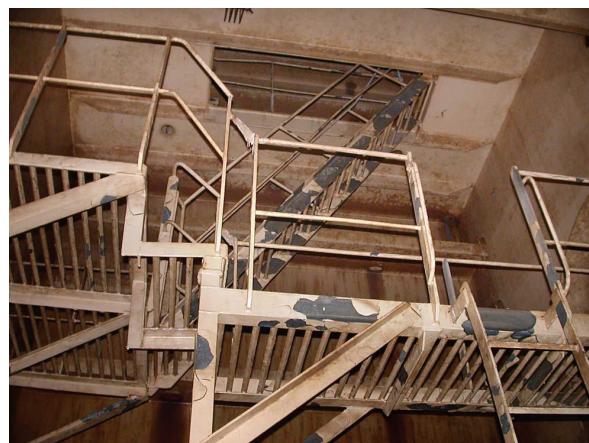
Many of the PMA are constructed from galvanised steel to provide an enhanced life to the structure. However, the galvanised surfaces must be carefully prepared and painted, otherwise the zinc on the PMA can act as part of the ballast tanks cathodic protection system, as shown in photograph 2.

In these cases, the galvanised layer dissolves sacrificially to protect the steel. This forces the coating off the PMA and allows premature corrosion of these structures. The inclusion of additional sacrificial anodes may be required specifically to protect the PMA.

Photograph 2. Corroding zinc on the PMA itself is removing the paint.

Maintenance and repair of the coatings on PMA will become increasingly difficult with time in service due to the problems of successfully painting corroding zinc layers. This is in addition to the many other difficulties encountered in painting complex structures under service conditions. Such problems include cleaning, surface preparation, paint application, and paint curing. All of these are difficult to achieve well whilst at sea.

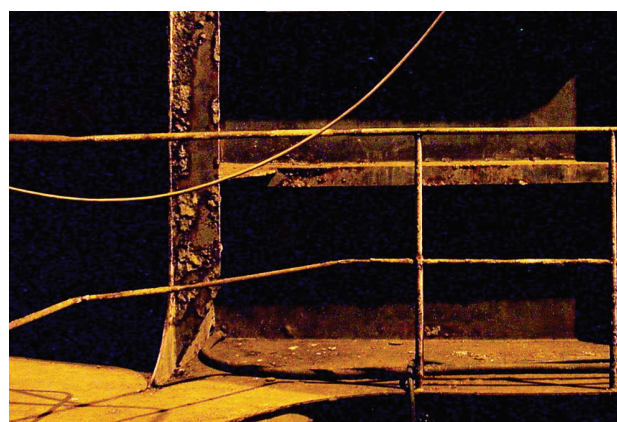
Good maintenance and repair of the paint is essential to prevent metal loss due to corrosion, as shown in photograph 3.

Photograph 3. Corroded PMA.
