THE FLOODING AFTER DAMAGE OF A WARSHIP WITH COMPLEX INTERNAL COMPARTMENTS – EXPERIMENTS ON A FULLY CONSTRAINED MODEL IN CALM WATER AND REGULAR BEAM SEAS

G J Macfarlane and **M R Renilson**, Australian Maritime College, University of Tasmania, Australia
T Turner, Defence Science & Technology Organisation, Australia

SUMMARY

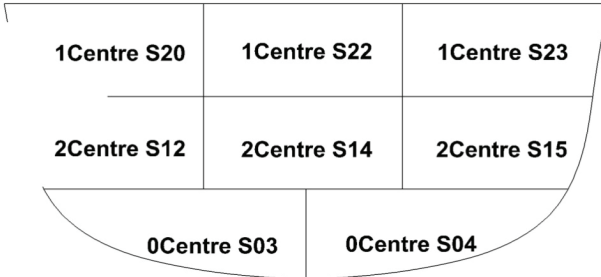
Figure 2b Cross-section BB

The layout of compartments for each of the three deck levels are shown in Figure 1(a, b and c) and cross sections at locations AA, BB and CC are provided in Figure 2(a, b and c). Detailed information about the model, such as the compartment dimensions and volumes; the names, locations and sizes of each of the hatch openings and doorways between the internal compartments; locations of each sensor; and details of the damage to the hull, bulkheads and decks, are provided in Macfarlane and Renilson (2010) and Macfarlane and Hutchison (2010).

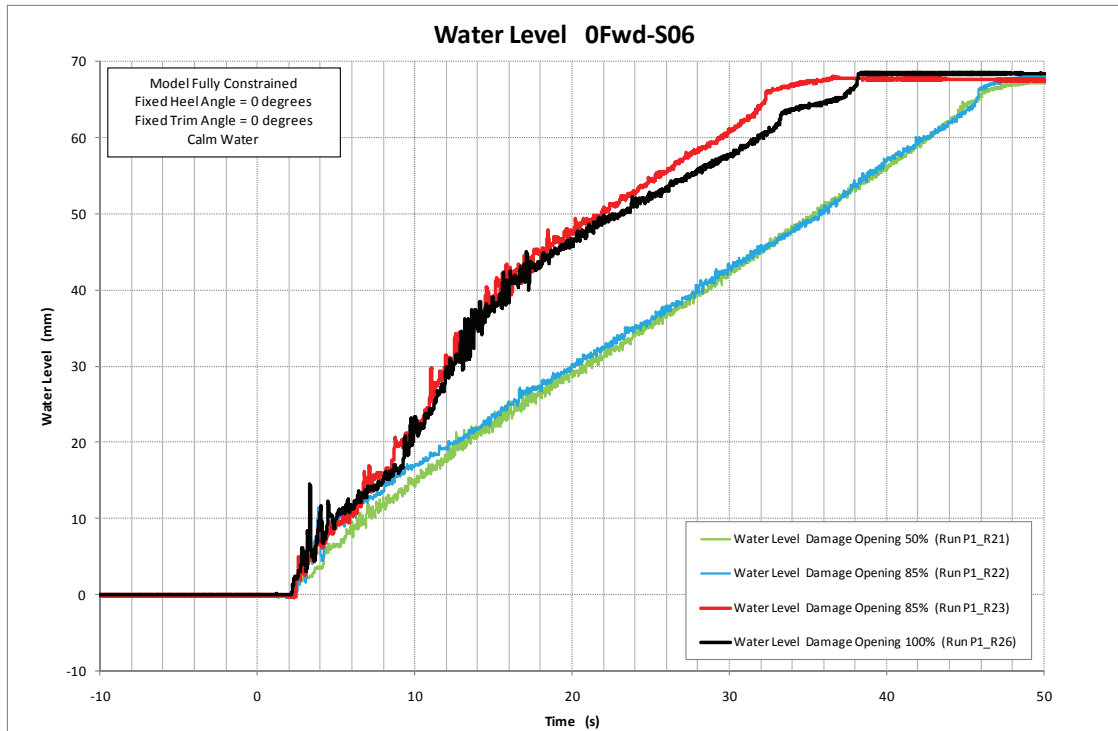
Figure 4 Water level at 0Fwd-S06 as a function of time

The water levels in the lower tank on the starboard side (0Fwd-S06) are plotted as functions of time in Figure 4. As can be seen, there are two distinctly different patterns: one where the water level increases slowly and consistently; and one where the water level increases rapidly to begin with, and then levels out. In each case the tank was full at the end of the run (the slight differences in equilibrium water level are within the expected level of uncertainty).

It was observed that for the cases where the water level increased rapidly, a vortex was formed in the water on the 2nd deck above. This meant that air escaping from this compartment had a direct path to the atmosphere. On the other hand, for the runs where the water level filled more slowly such a vortex did not appear, and consequently the air could only escape from this compartment more slowly as a series of bubbles. This was visible within the footage from the internal video camera. It is unknown as to what triggered this vortex to occur during some runs and not in others.

Note that the area of the damage opening varied between the four runs shown in Figure 4, however it is assumed that this had little effect on the rate at which tank 0Fwd-S06 filled due to its location and because it filled through a down flooding hatch.

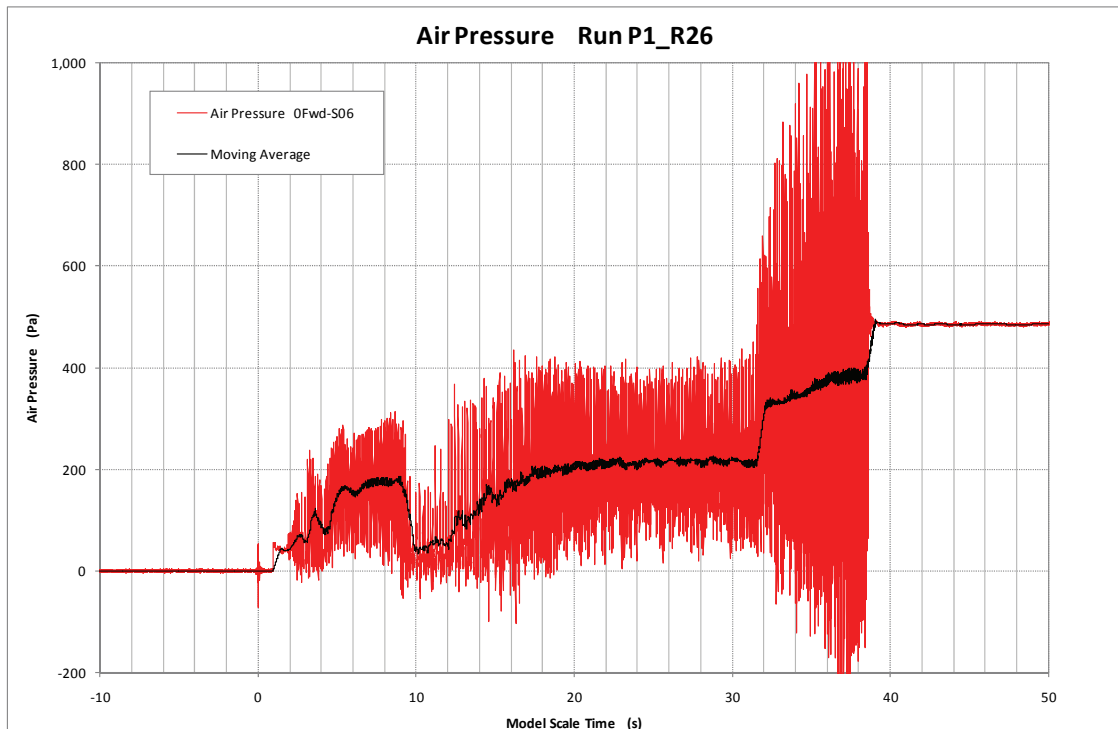
Figure 5 Air pressure in tank 0Fwd-S06 as a function of time

Figure 5 is a plot of the change in air pressure as a function of time within compartment 0Fwd-S06, which was located in the forward lower starboard tank (see Figure 1). As can be seen, there was considerable noise in the signal as water was entering the tank, however the signal noise level dramatically decreased as the water level within the tank reached equilibrium after just over

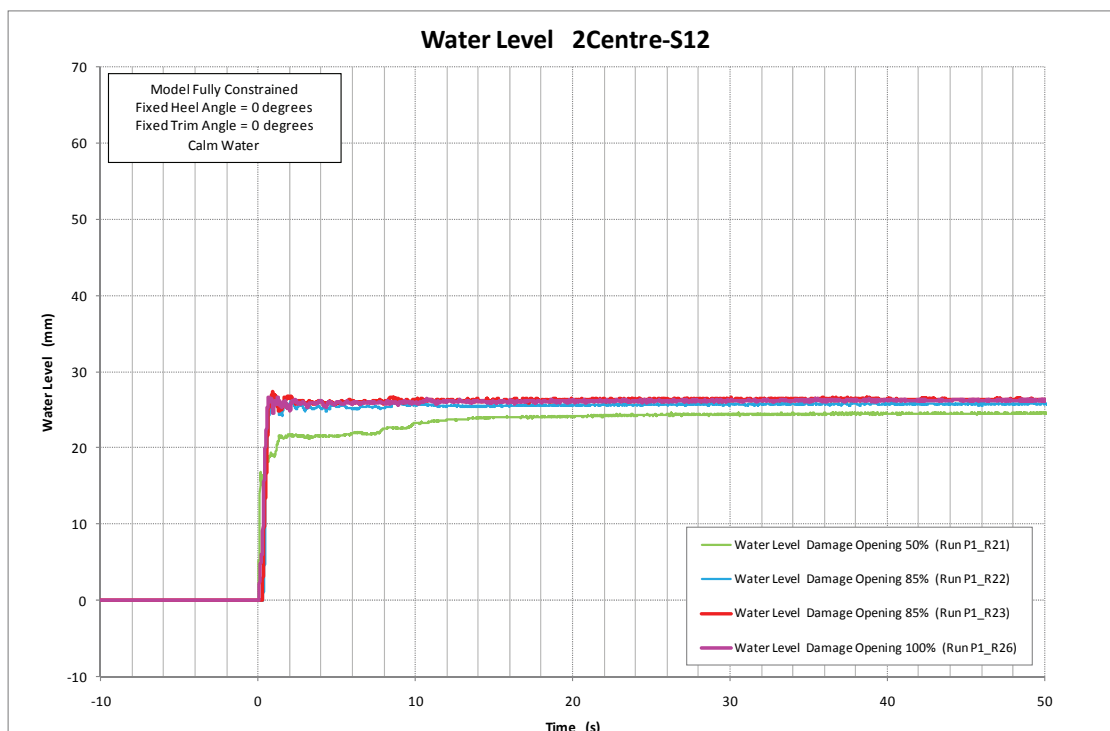
Figure 6 Water level at 2Centre-S12 as a function of time

The water levels in the centre tank on the starboard side (2Centre-S12) are plotted as functions of time in Figure 6. Here the levels all rise very quickly, with only the result for the 50% damage opening (Run P1_R21) being slightly slower. All reach the same approximate equilibrium position, as this wave probe is in the free flooding space close to the damage opening. This small effect that the 50% damage opening has on the filling rate can also be seen in Figure 9, where the water levels within tank 2Centre-S12 at time $t = 10$ s are plotted. At this point in time, the water level is about 3mm lower than the cases where at least 85% of the damage area is open.

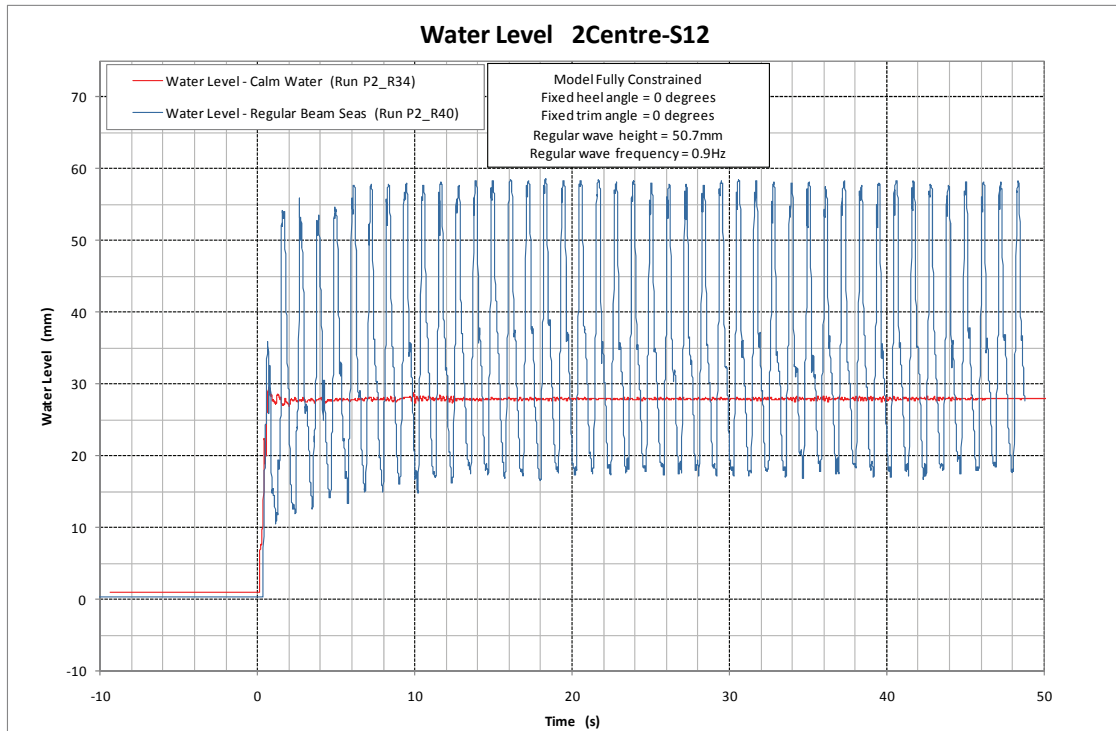
Figure 11 Water level at 2Centre-S12 as a function of time

The water levels in compartments 0Fwd-S06, 2Aft-S11, 2Centre-S12, 2Centre-S15 and 2Fwd-S16 from a test in calm water are compared against results from a test in regular beam seas with nominal wave height of 50mm and wave frequency of 0.9Hz, see Figures 10 to 14, respectively. For all these tests the damage opening is facing the oncoming waves and the model is fixed at level heel.

As expected, the incident waves cause the water level in the compartments to also oscillate, which generally occurs at wave frequency, although the variation in water elevation is more complicated due to wave reflection and refraction within the compartments. The magnitude of the oscillations in water level tends to be greatest within those compartments that have more direct access to the damage opening. For example, wave oscillations of up to approximately 40mm occur within compartment 2Centre-S12, which is fully exposed to the damage opening, whereas this reduces to as low as approximately 10mm for 2Centre-S15 and 5mm for 2Aft-S11 (the incident wave height was 50mm). Both of these compartments are located on the port side of the model where the waves need to travel through open doors and adjoining compartments.

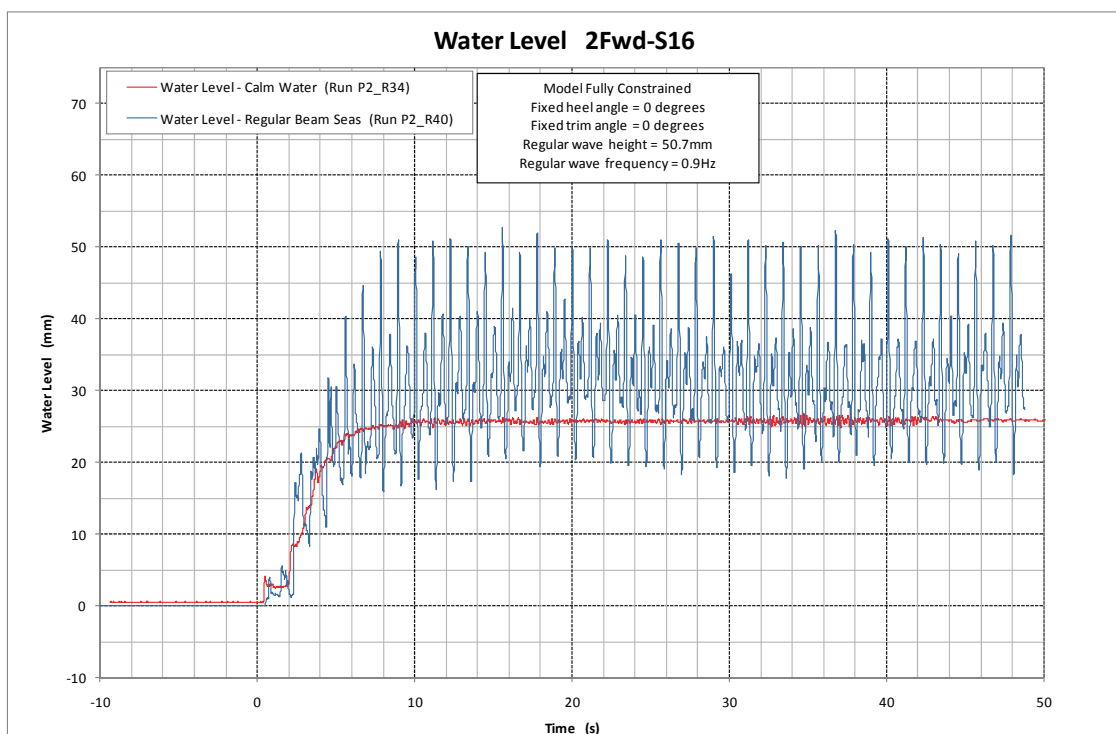
Figure 14 Water level at 2Fwd-S16 as a function of time

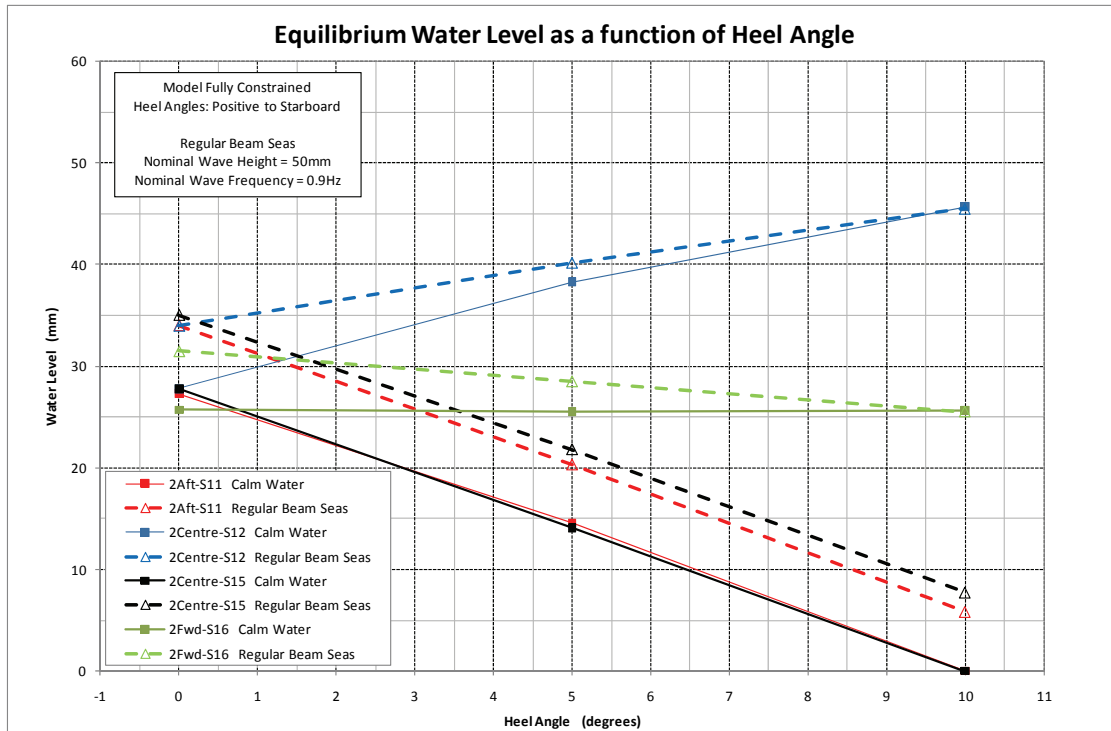
Figure 15 Equilibrium water level as a function of heel angle

Further calm water and beam sea tests were conducted with the model at fixed heel angles of 5 and 10 degrees (both to starboard – *i.e.* towards the damage, which is facing the oncoming waves). Figure 15 presents a cross-plot of the equilibrium water levels as a function of heel angle. As can be seen, a set-up in water level of similar magnitude occurs at both port-side compartments (2Aft-S11 and 2Centre-S15) at each of the three fixed heel angles (0, 5 and 10 degrees).
