THE CHALLENGES OF MAJOR TANK COATING REFURBISHMENT PROJECTS FOR ON-STATION FLOATING ASSETS

(DOI No: 10.3940/rina.ijme.2020.a2.564)

A Westwell, Marine Technical Limits, UK

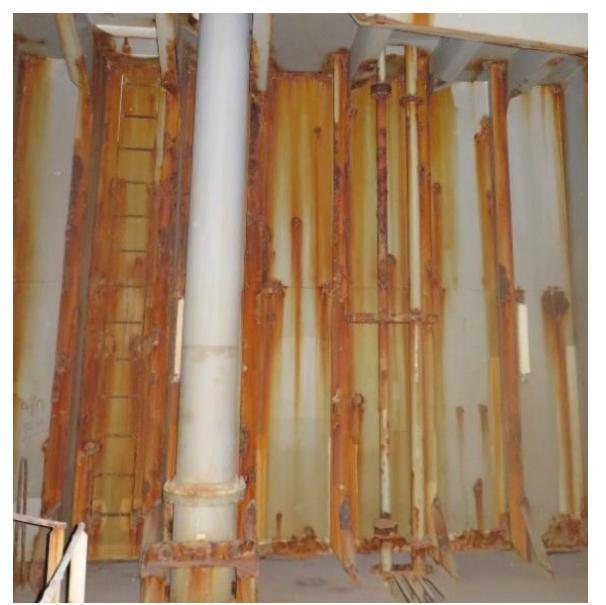
Figure 1. FPSO fore peak tank with coating breakdown. Photographed by Marine Technical Limits.

Worldwide there are over 180 operational Floating, Production, Storage and Offloading Unit's (FPSO's) and Floating Storage Unit's (FSU's) currently in-service, with approximately 60% of those assets being over 10 years old [1]. As vessel's age, the coating systems installed to the hull during construction (or conversion) begin to deteriorate, as demonstrated in Figure 1 below.

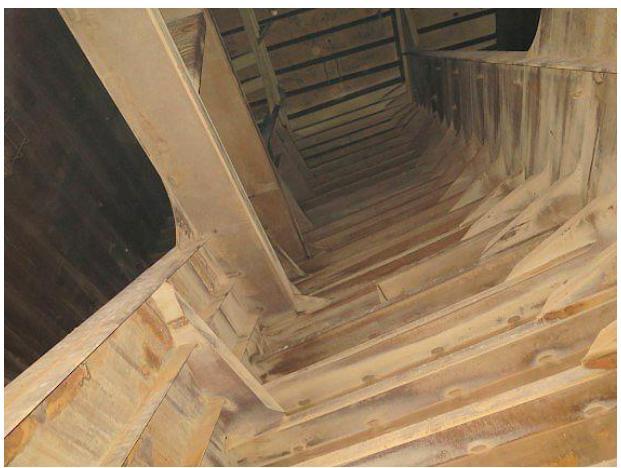
Figure 2. FPSO slop tank internal structure. Photographed by Marine Technical Limits.

It's important to fully understand the structural configuration of the tank(s), to fully define and engineer appropriate means for executing the workscopes. For stiffened bulkheads, for example, safely accessing all of the stiffener free edges for surface preparation and stripe coating is often a sizeable and hazardous task. Figure 2 below provides an example of a heavily stiffened tank structure. Horizontal stiffeners tend to collect dust and debris on the horizontal webs, which can create an additional challenge during grit recovery and clean-up, especially when working at height. Figure 3 provides an example of a scaffold structure built to provide access to internal tank surfaces for coating works.

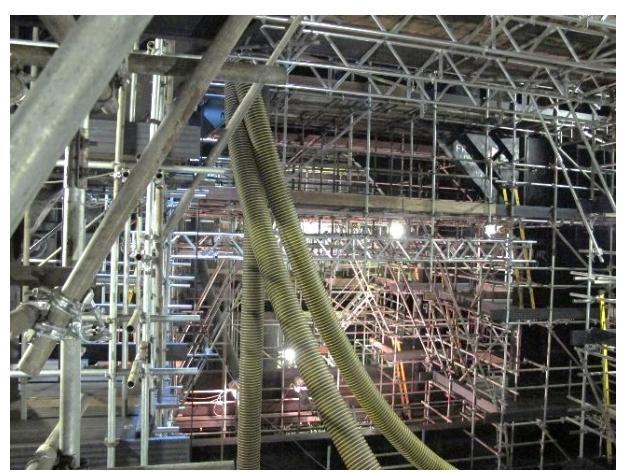
Figure 3. FPSO tank with scaffolding to structure. Photographed by Marine Technical Limits.

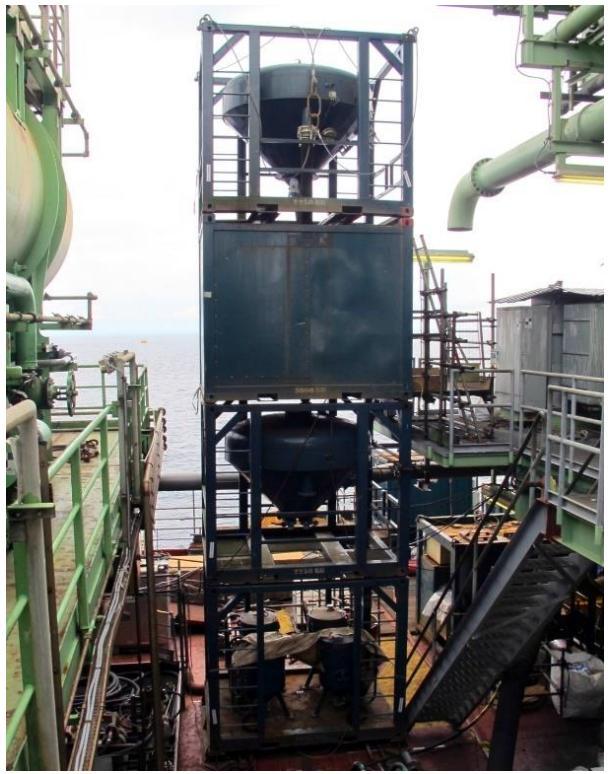
Figure 4. Abrasive recycling system onboard an FPSO. Photographed by Marine Technical Limits.

It is important to select an appropriate blasting media when using air blasting. Large volumes of media can be expended, particularly when blasting large surface areas, which can create a burden of waste disposal if using cheaper single use media. Selecting a media which can be recovered, recycled to remove any entrained impurities, and reused has clear advantages for hull structure blasting, especially when considering the challenges of material handling and storage of waste on an offshore asset (with often limited laydown availability), and the logistical challenges of returning waste to shore-base for disposal. Figure 4 shows a typical abrasive recycling system for large scale blasting projects. Suitable areas to position equipment with a footprint and height of this nature may prove challenging and should be considered during engineering.

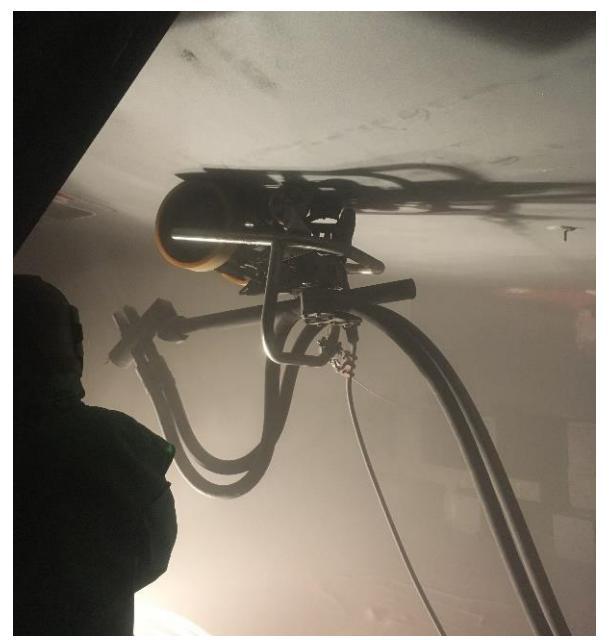
Figure 5. Robotic crawler performing dry abrasive blasting activities on a ship's hull. Photograph courtesy of VertiDrive.

Similar to the uptake in using remotely operated vehicles and unmanned aerial vehicles, the development and use of remotely operated crawlers are gaining in popularity in shipyards for blasting, particularly for large flat areas of plating.

Controlled by a single operator and using the same blasting equipment that would be used by a conventional blasting operative, these systems have high production rates, and are able to access at height areas without the need for scaffolding or rope access techniques. Figure 5 provides an example of this technology being used, and shows the benefits it can provide to difficult to reach atheight blasting locations.

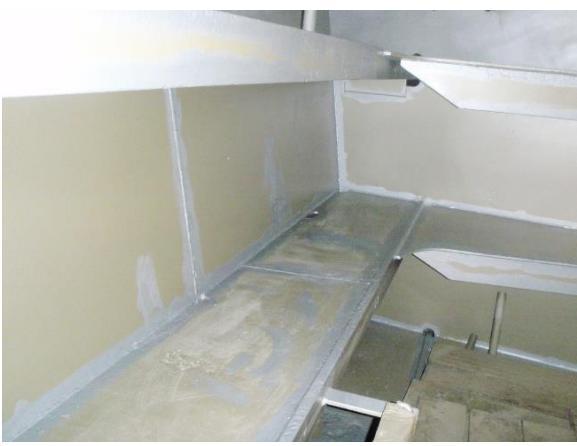
Figure 6. Stripe coating applied to ballast tank internal structure. Photographed by Marine Technical Limits.

Stripe coating should be carried out using a paint brush and should be applied either before or after the first full coat and repeated before the application of any subsequent full coats. For large areas of prepared steel, it is sensible to apply the initial full coat, followed by the initial stripe coating of the free edges, welds and corners. This will ensure that the large areas of prepared steel do not suffer from flash rust prior to the application of the first coat. Figure 6 shows the application of stripe coating to the free edges of stiffeners within a ballast tank.

Contrasting colours of paint for the stripe coating and full coating should be used where possible to ensure easy verification of areas which have been stripe coated and subsequently fully coated.

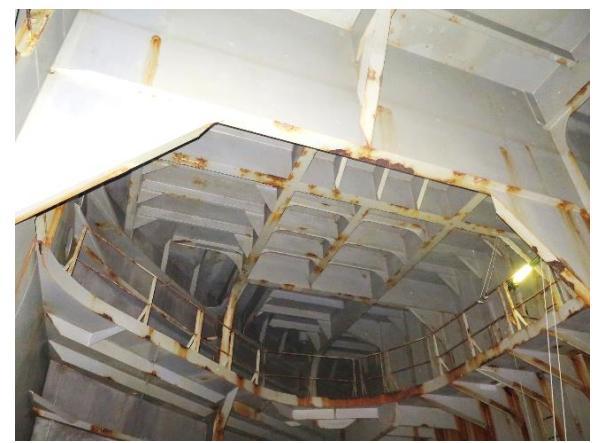
Figure 7. Stiffened structure with signs of deterioration. Photographed by Marine Technical Limits.

The structural configuration of the tank being painted will dictate the ease of access for stripe coating. For heavily stiffened bulkheads, it may be more beneficial to erect scaffolding to aid access and improve efficiency of stripe coating these areas. For more remote and/or isolated areas of stripe coating, it may be more efficient to perform the stripe coating using rope access techniques. Figure 7 above shows an example of a fully coated tank and the access challenges which may be presented should a full coating refurbishment be necessary.
