## EXPERIMENTAL AND NUMERICAL STUDY ON PROGRESSIVE FLOODING IN FULL-SCALE

(DOI No: 10.3940/rina.2010.a4.195)

### SUMMARY

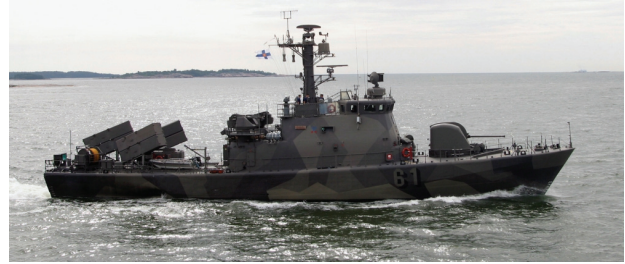
Figure 1: Fast Attack Craft *Turku* (photo credit: Finnish Defence Forces)

The vessel that was used in the tests is a decommissioned Fast Attack Craft *Turku* of the Finnish Navy (Figure. 1). The principal dimensions of the vessel are listed in Table 1. The weapon systems had been removed and additional weights were used to compensate this.

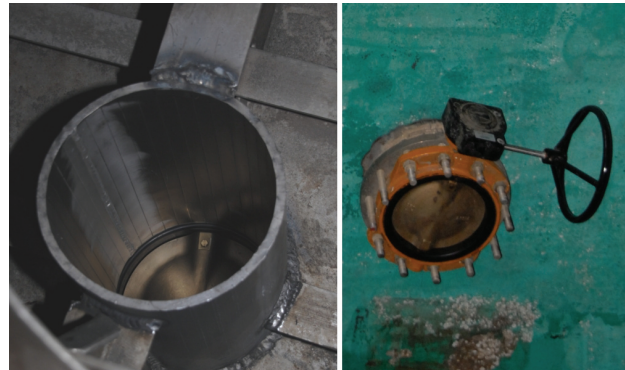
Figure 2: Butterfly valve used as a damage hole

Flooding of two watertight compartments was allowed. A butterfly valve with a diameter of 250 mm was installed on the side shell of the starboard side empty tank (Figure. 2), about 1.1 m below the waterline. The valve was opened by a diver in order to let the water flood in. The flooded compartments consist of empty tanks, pump room, equipment room and an empty store. An additional opening was installed on the transverse

The local flow velocities at the damage hole and in the end of the smaller air pipe were also recorded. After the valve (Figure. 2), the flow velocity close to the pipe surface was measured by using a paddle wheel transducer. The airflow velocity was measured with a pitot tube in the centre of the small air pipe from the SB side tank.

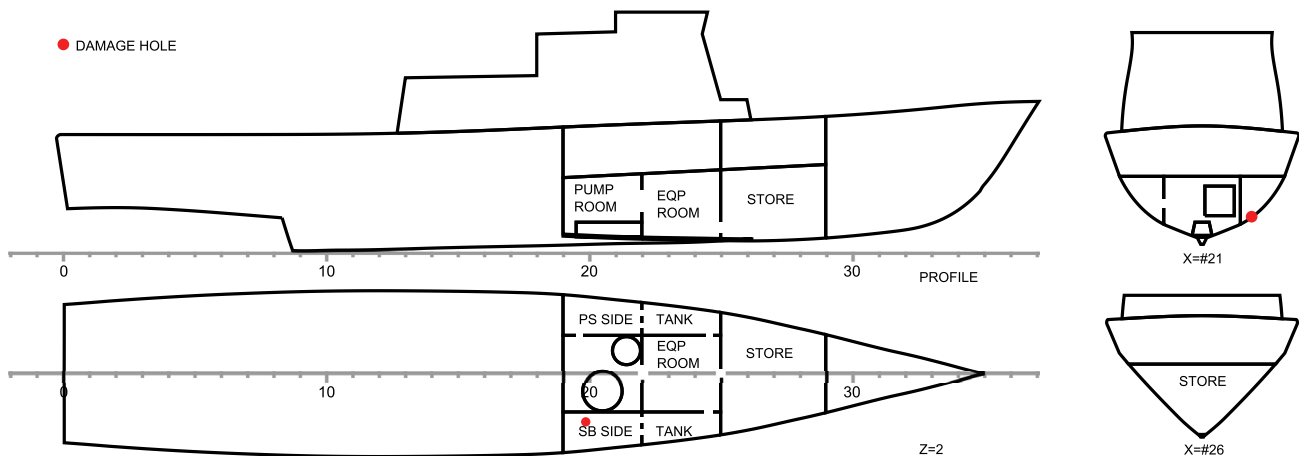
Figure 3: General arrangement of the flooded compartments.

bulkhead at frame #25 in order to allow flooding to the store room in the forward compartment. The general arrangement is presented in Figure. 3. Photos of the rooms and openings are shown in Figure. 4 and 5, respectively.

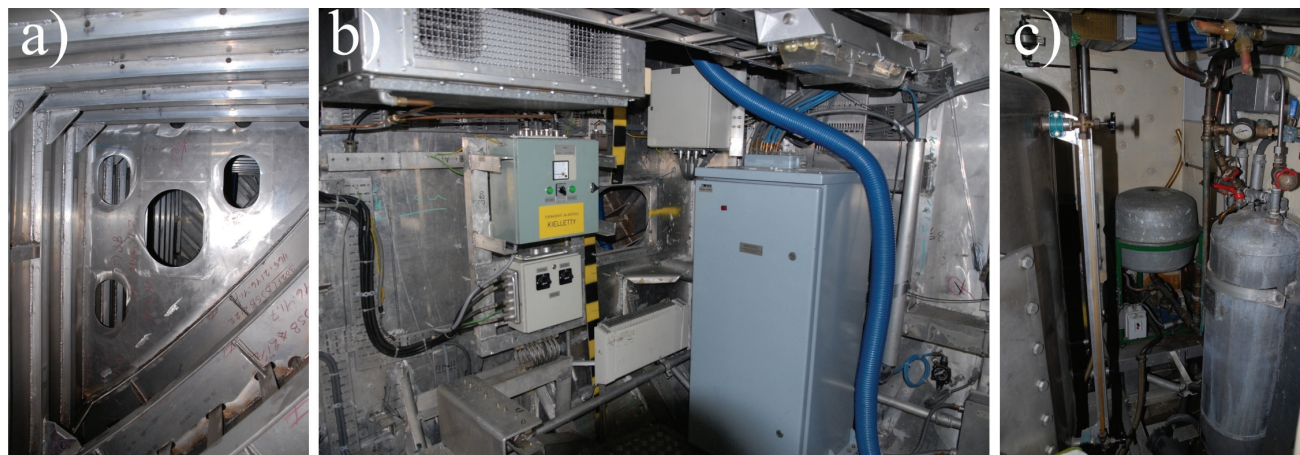
Figure 4: Flooded compartments: a) side tank with anti-sloshing bulkhead, b) equipment room and c) pump room

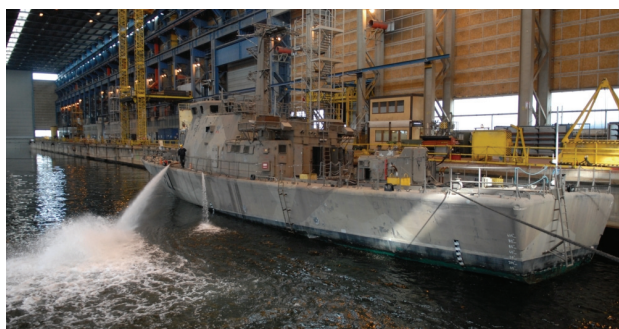
Figure 6: Pumping after a flooding test

After each test, the damage hole (i.e. the valve) was closed and the flooded water was pumped out (Figure. 6). This arrangement proved to be very successful and only minimal amount of water was left in the bilge. Therefore, each test started from almost identical intact condition. The very small changes in the initial heeling angle were taken into account in the simulations. The powerful pumping equipment allowed fast emptying of the flooded compartments, thus making it possible to do several tests within a short time.

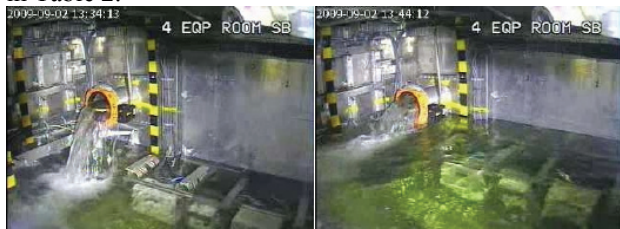
Figure 8: Different flow conditions of the valve between the side tank and the equipment room

Special attention was paid to the two (almost identical) valves since they included a short pipe. After the flooding tests, one valve was removed and extensively tested in the flume of the Water Engineering Group of the Aalto University School of Science and Technology. Most notably, different values were eventually used for these valves due to the completely different flow conditions. The "damage hole" valve is submerged very rapidly and discharges to water with a large pressure head most of the flooding process. The valve that is located between the side tank and the equipment room discharges to air with a small pressure head for a very long time. This is taken into account by applying a smaller discharge coefficient. On the other hand, when

this valve is fully submerged a larger coefficient is needed. The different flow conditions are illustrated in the video captures in Figure. 8. Consequently, two separate values are used for this opening, depending whether the discharge is to water ( $C_d = 0.70$ ) or to air ( $C_d = 0.41$ ). All the applied discharge coefficients are listed in Table 2.

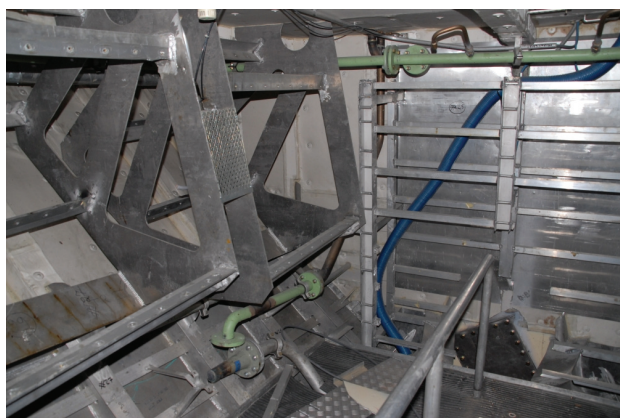
Figure 9: Empty store in the forward compartment
